MARINE EXPOSURE TESTS ON STAINLESS STEEL SHEET

By Willard Mutchler

National Bureau of Standards

Washington
February 1947

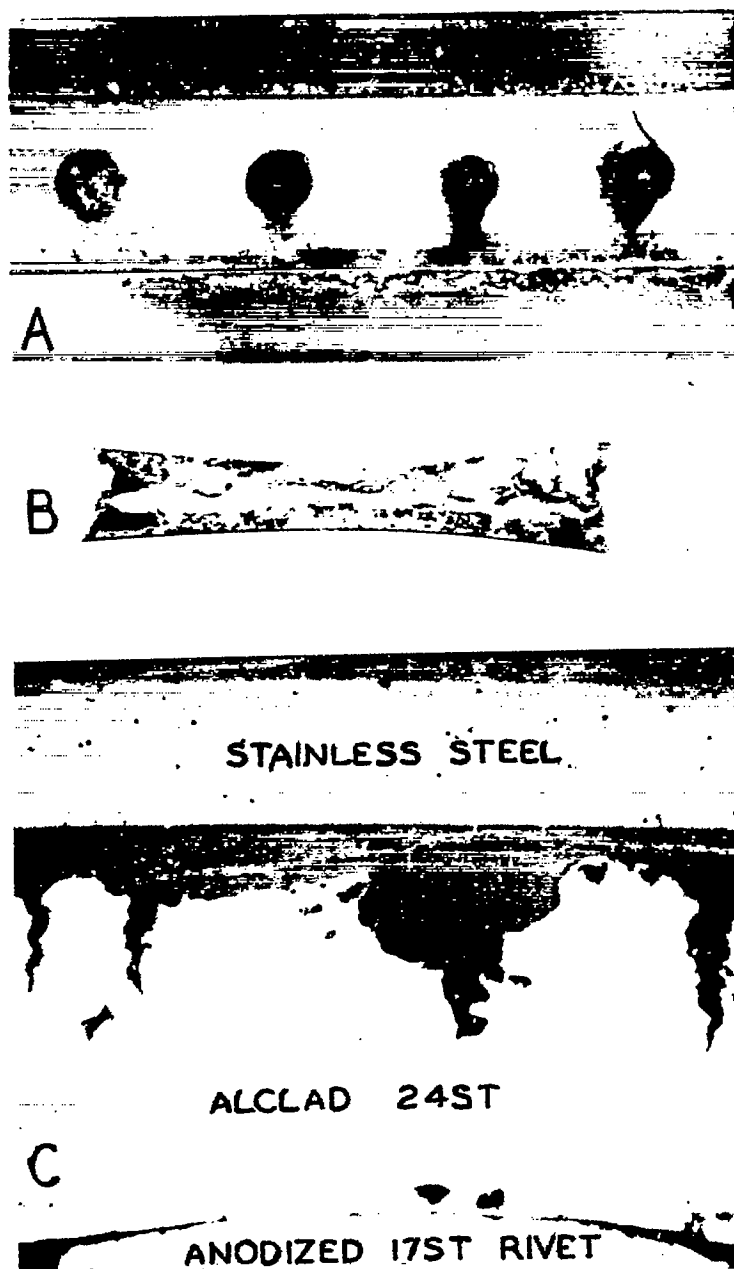
Figure 31.- Examples of stress corrosion on panels having stainless steel coupled with light metal alloys. A, Crack on stainless steel strip joined to a magnesium alloy panel, Dowmetal M. Exposed two years to the weather, earthward surface. x 1. B, Cross-section showing the large amount of corrosion products at the faying surfaces of (A). x 2-1/2. C, Cracks in Alclad 24ST strip attached to a stainless steel panel, exposed to tidewater for two years. x 50.
